DAMAGE BY GOLDEN-FRONTED AND LADDER-BACKED WOODPECKERS TO FENCE POSTS AND UTILITY POLES IN SOUTH TEXAS

JOHN V. DENNIS

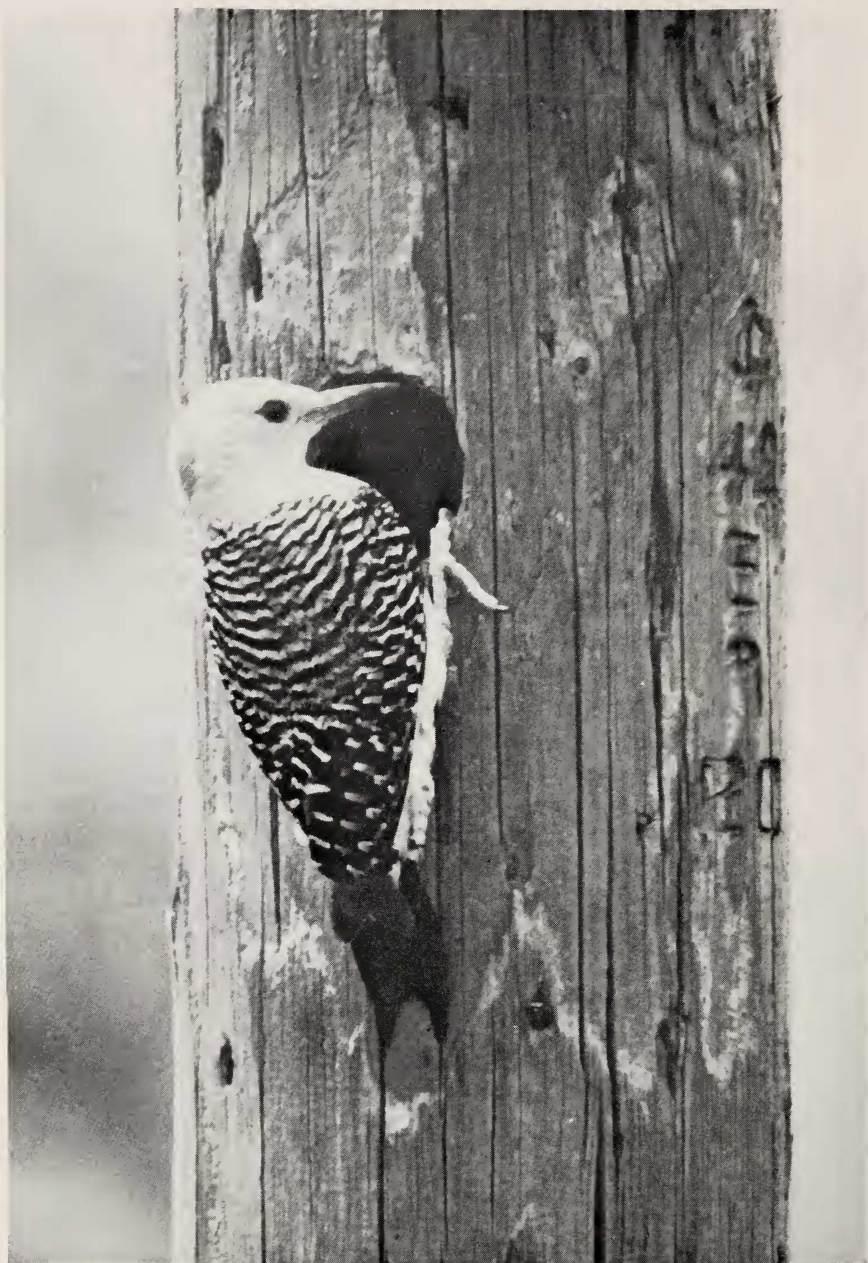
FIG. 1. Female Golden-fronted Woodpecker at nest hole in a small electric distribution pole. Hole is about six feet from the ground.

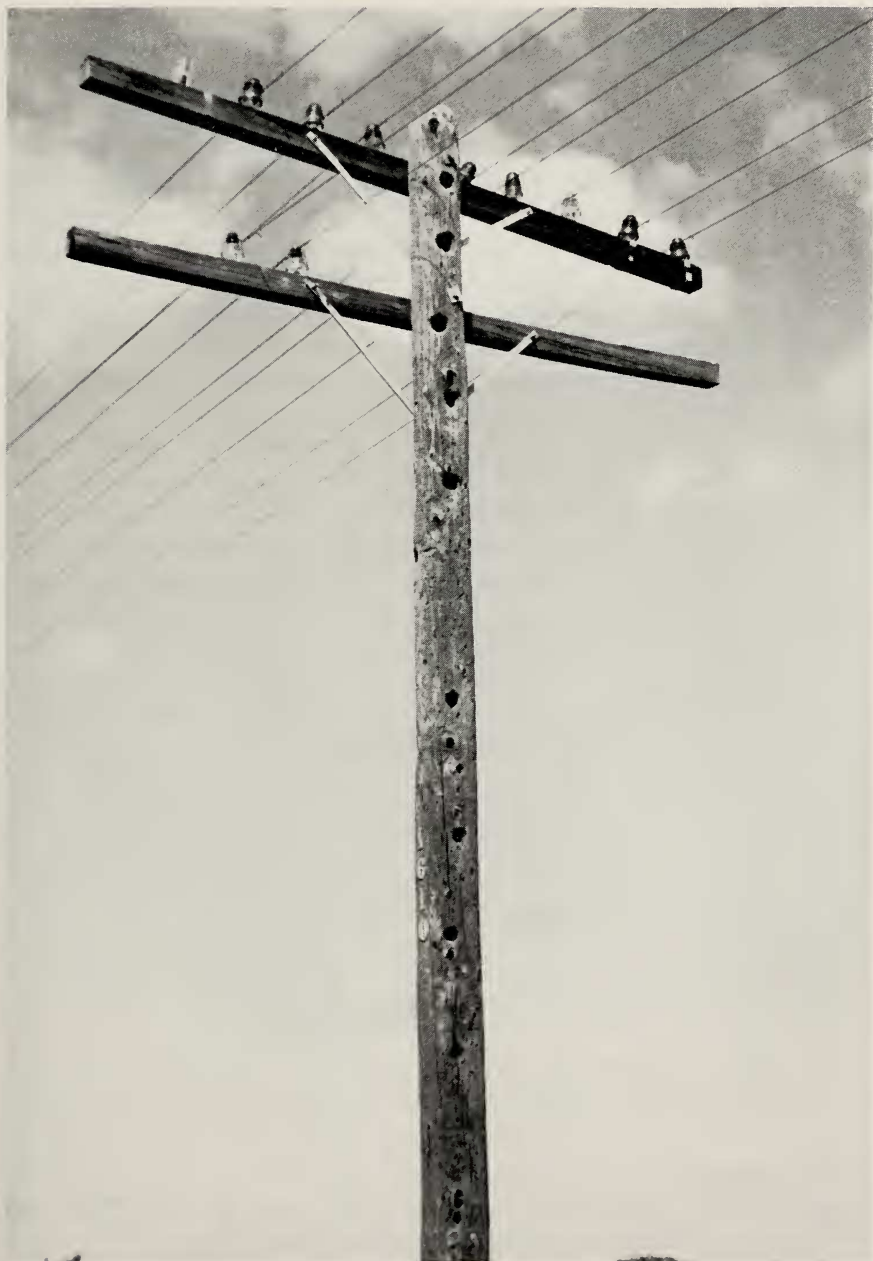
FIG. 2. Distribution of holes on this telephone pole is typical of Ladder-backed's work. Heaviest attack is near the top of pole. A few holes are found on the lower portion and beginning almost from the ground level.

Attack on utility pole structures by the Ladder-backed is characterized by heavy damage to crossarms and braces, and frequent heavy damage to the top 2 or 3 feet of the pole. Damage sometimes extends from ground level to the top of the pole (Fig. 2). Attack on crossarms and braces always originates on the underside, never the sides or top. Typically, a crossarm is drilled at a site on the underside from 6 to 18 inches from the end. The purpose of this drilling is apparently the excavation of a roosting or nesting hole. Rarely are these holes completed. Often the bird "misjudges" the dimensions of the crossarm and breaks "windows" in one or both sides, or breaks a hole in the top. In other cases, the bird appears to tire of its work and discontinues after drilling only an inch or two. In the rare instances that a cavity is completed, the tunnel always leads from the entrance toward the pole—never away from the pole. Completed cavities in crossarms are from 6 to 10 inches in length.

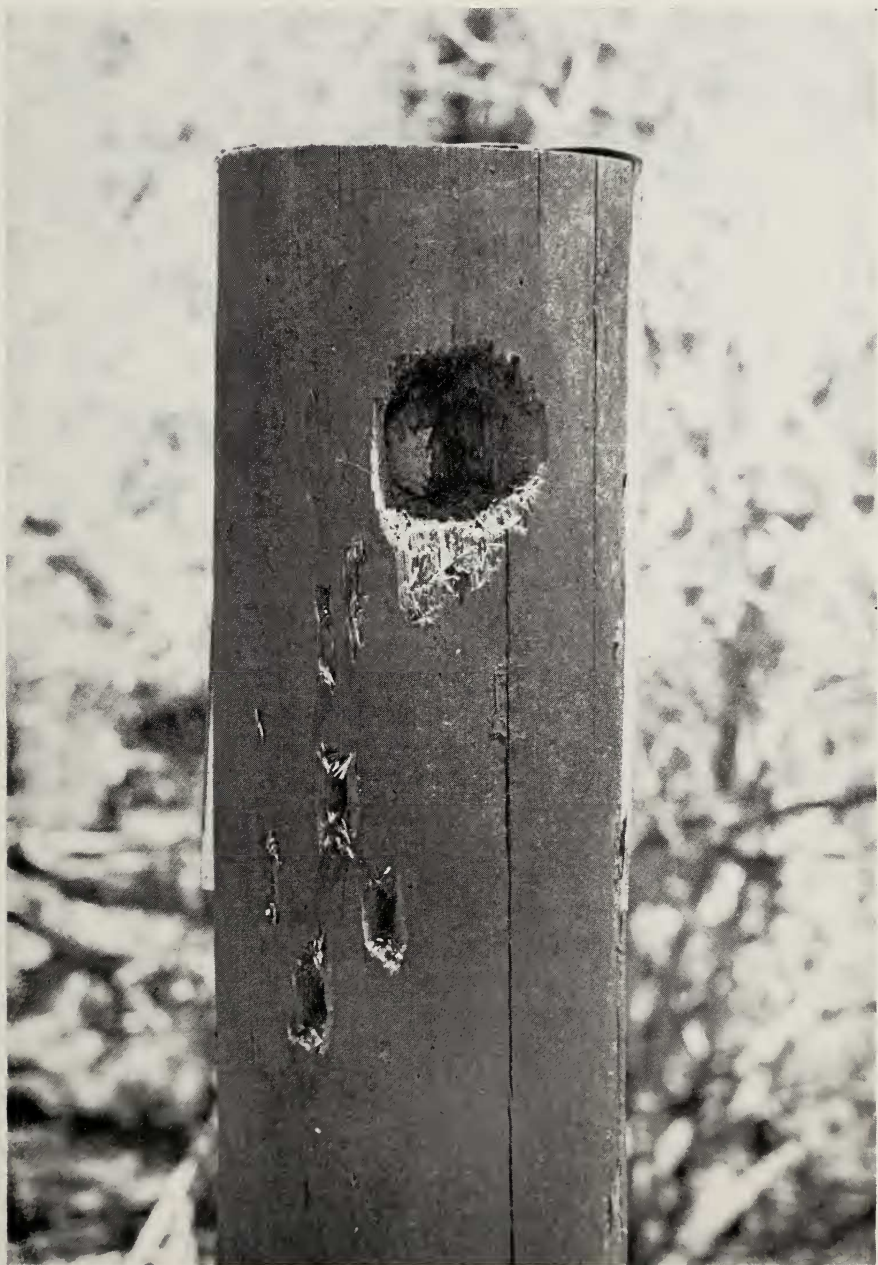
This tendency to attack locations opposite metal attachments was tested on a small scale in fence post experiments at the Laguna Atascosa Refuge. A slit 5 inches deep was sawed into the top of 10 creosoted pine fence posts. A 5-inch square of sheet metal was inserted into each slit. Posts containing the hidden metal plates were placed in test strips with 30 unaltered creosoted pine fence posts. As with the other test posts, placement was made in late February and posts were checked in late April. Of the 30 unaltered posts, six (20 per cent) had been attacked; of the 10 posts with metal plates, seven (70 per

FIG. 3. A flat metal plate has been inserted into a groove cut into the top of this creosoted pine fence post. A woodpecker has drilled a hole to the plate. Small holes are scattered about near the large hole.

cent) showed attack. Figure 3 shows attack at a post with a hidden metal plate.
